# Manhole Inspection Summary

Manhole # S45MM\_042MH

Insp Date: **3/25/08 1:07 PM**

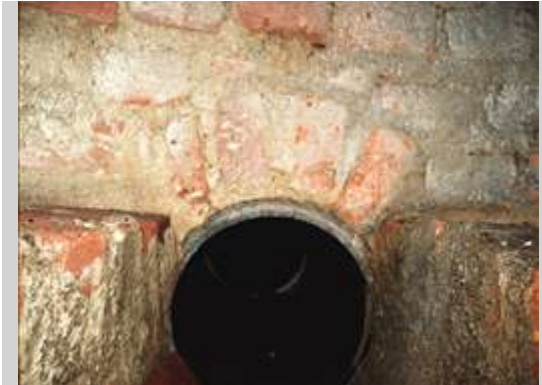
8 in. Circular Gravity Sewer  
Pipe Out @ 12 O'Clock

Pipe Height: **8.4** (in.) Rod and Bar (Angled)  
Pipe Material: **Clay** ☐ Pipe Lined  
Invert Depth: **6.90** (ft.) Flow Characteristics: **None**  
Deposits: ☒ None ☐ Mud ☐ ~~Gravy~~ ☐ Debris ☐ Grease  
Silt Depth: (in.) Deposits Extent:  
Infiltration: **None** Pipe Seal Cond: **Sound**

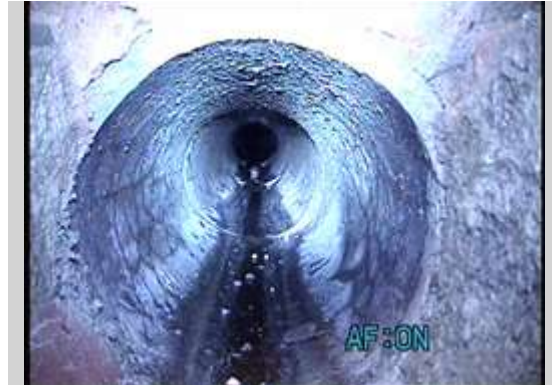
12 O'Clock Outflow  
Pipe Out @ 12 O'Clock

Pipe Height: **8.4** (in.) Rod and Bar (Angled)  
Pipe Material: **Clay** ☐ Pipe Lined  
Invert Depth: **6.80** (ft.) Flow Characteristics: **None**  
Deposits: ☐ None ☒ Mud ☒ ~~Gravy~~ ☒ Debris ☐ Grease  
Silt Depth: **3** (in.) Deposits Extent: **Medium**  
Infiltration: **None** Pipe Seal Cond: **Sound**
